SNOW STUDIES ASSOCIATED WITH THE SIDEWAYS MOVE OF DYE-3

Wayne Tobiasson

U.S. Army Cold Regions Research and Engineering Laboratory
Hanover, New Hampshire

Proceedings of the Eastern Snow Conference, 36th Annual Meeting, Alexandria Bay, N.Y., June 7-8, 1979.

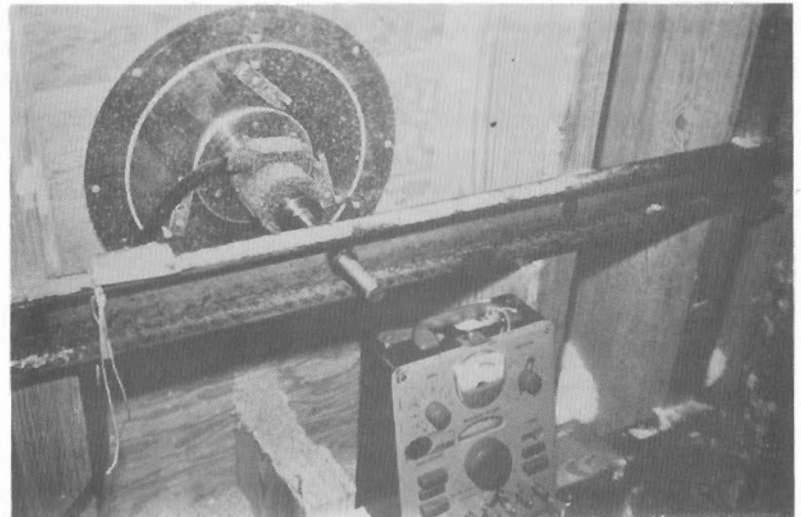
The truss enclosure was initially designed on the assumption that the lateral snow pressure on it at any depth was $1/3$ the overburden pressure at that depth. Pressure cells which Sherwood Reed and I designed and installed on the walls of the truss enclosure in the late 60's (Fig. 5) showed that the lateral pressure increased with depth from a value

of about 20% the overburden pressure near the surface to nearly full hydrostatic pressure at a depth of 80 ft (24 m) or more. The enclosure was strengthened in an attempt to sustain these increased lateral pressures and except in a few areas such as shown in Figure 6, the strengthening worked rather well.

Figure 5. Lateral pressure cell installed on the wall of the truss enclosure.

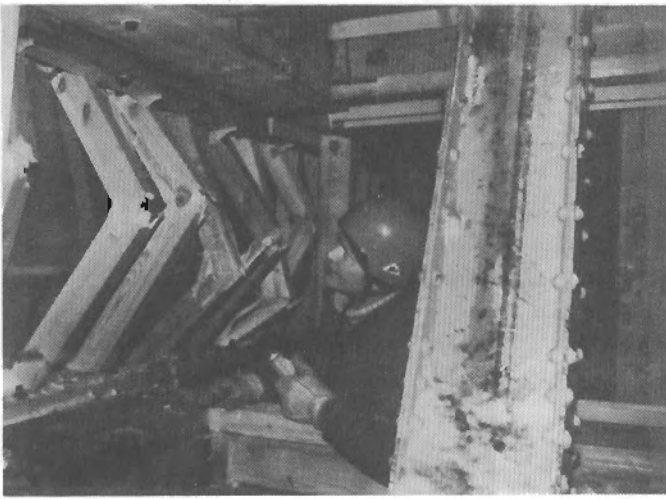
Figure 6. Failed wall studs of the truss enclosure (photo by E. Hodgkins, ADC).

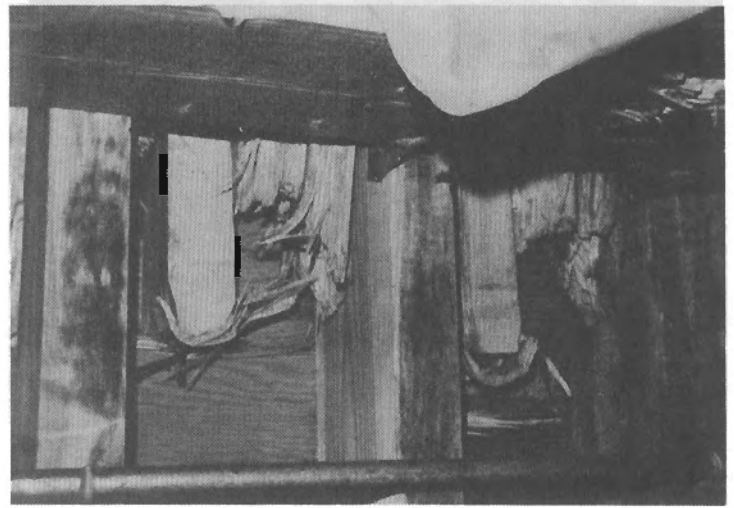
However, the truss enclosure soon showed that it had an inherent weak link. The adjacent densifying snow gripped it and created heavy vertical compressive stresses on the walls. For the most part, the wall studs themselves were capable of sustaining these stresses but the horizontal plates at the ends of the studs could not sustain them. Where the studs above and below were not aligned, the plates were subjected to heavy shear stresses and they failed. Lacking vertical support except from the adjacent snow, the walls slowly telescoped downward as the adjacent snow densified (Fig. 7). In many areas members of the telescoping truss enclosure interfered with the steel trusses (Fig. 8). Large secondary stresses were generated in the structural frame of the composite building by these interactions.

Figure 7. Failed wall plates and telescoping wall studs.

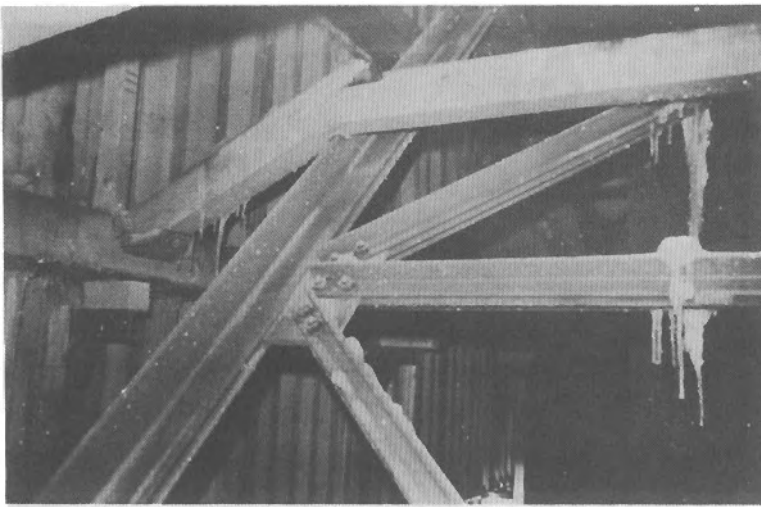
Figure 8. Interference between the timber truss enclosure and the subsurface trusses.

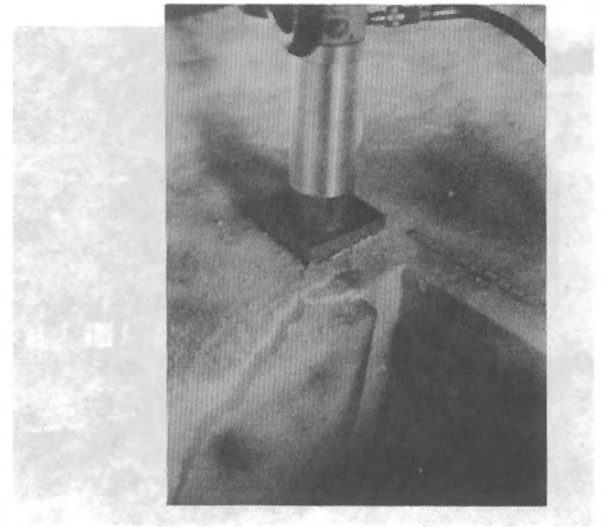
Model Tests: To determine the chances of an abrupt and catastrophic bearing failure, tests were conducted at DYE-3 of model footings placed near an excavation. The hydraulic jack in Figure 9 has pushed the model footing into the supporting snow which has failed. The failure load is related to the proximity of the footing to the excavation. Several repetitions of this test were conducted on site.

Unconfined compression tests of the same snow indicated that the snow supporting the model failed at a stress 3-1/2 to 7 times the unconfined compressive strength of that snow. These tests were somewhat primitive and the surface snow was not homogeneous. To better define the model/unconfined stress ratio, additional tests were conducted in the cold rooms of CRREL in Hanover, New Hampshire (Fig. 10). The model/unconfined stress ratio for these tests varied from 4.5 to 5.0. With knowledge of the unconfined compressive strength of the snow that would support the actual footings, the load expected to cause failure of those footings could be estimated.

Figure 9. Model footing test conducted at DYE-3 under a crane which provided reaction for the hydraulic jack shown.

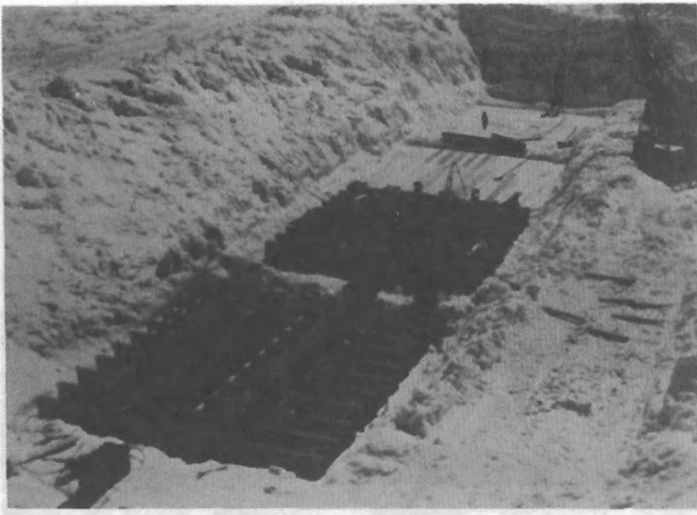
Figure 11. New footings (photo by R. McLemore, Metcalf & Eddy Inc.).

Danish Arctic Contractors (DAC) was awarded the contract to move the building. During the summer of 1977 new footings were built on the snow (Fig. 11), large girders were built on them (Fig. 12) and trusses and girders were installed under the building (Fig. 13). Hydraulic jacks were installed to pull the building along the tracks (Fig. 14). On 2 September 1977 with the columns severed and the weight of the building on rollers, the sideways move began. Four days and 210 ft (64 m) later the building was in its new position (Fig. 15). No particular problems were encountered during the move. The building was occupied and functional the entire time. During the move Bob McLemore of M&E and I measured the settlement of all footings. The total settlement was about 3/8 in. (1 cm) which is in line with the predicted value considering the move took only four days and it was a colder than normal summer.

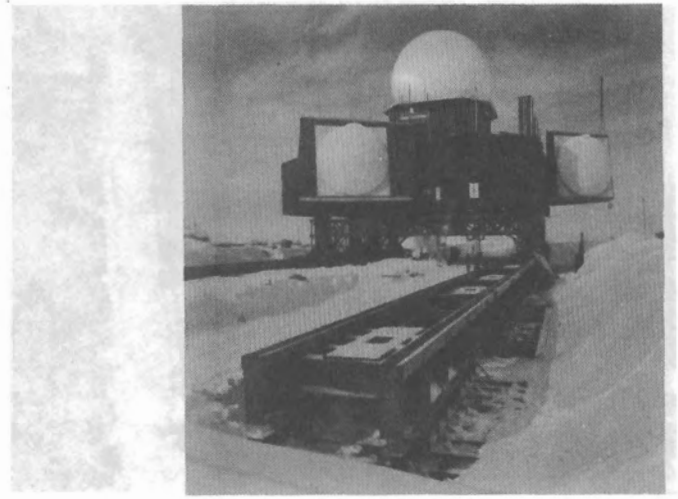
Figure 12. Girders over which DYE-3 was moved sideways.

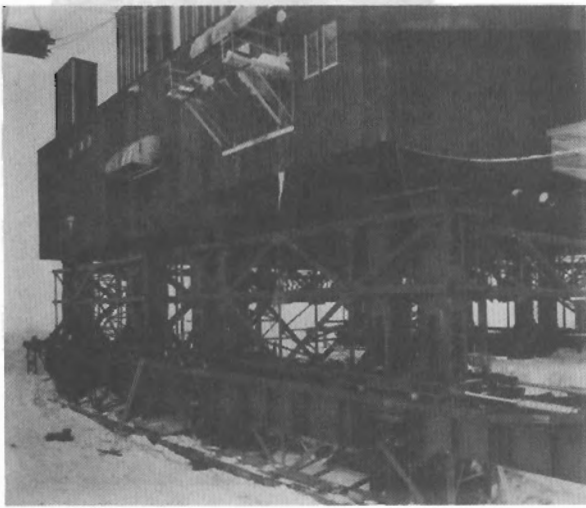
Figure 13. Trusses and girders installed under the building.
