METHODOLOGY USED IN GENERATION OF SNOW LOAD CASE HISTORIES

Donald McLaughlin¹ and George Duggan²

Introduction

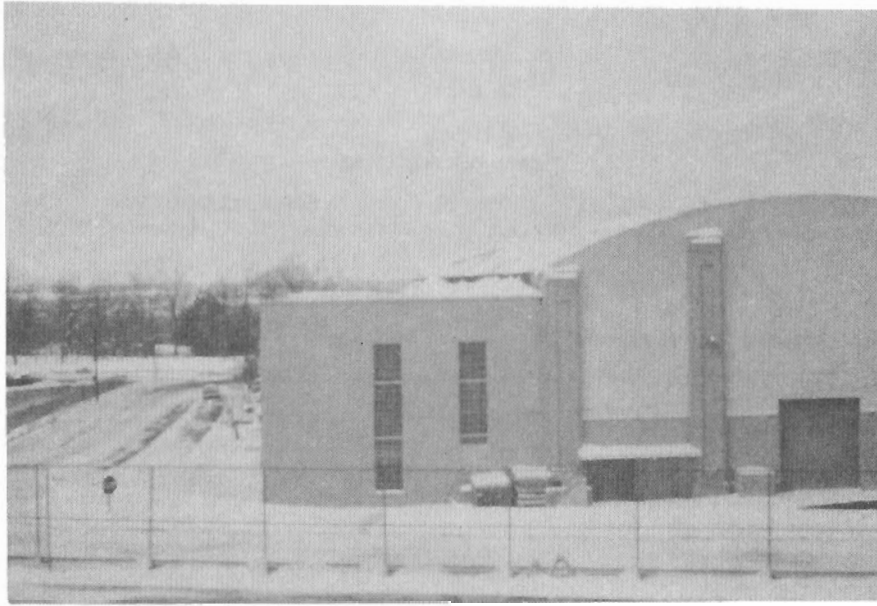
FIGURE 7 Snow Sliding Off Arched Roof

The special problems of sliding snow and roof icings were also observed at several locations and recorded on the data sheets. Typical examples are shown on Fig. 7 through 11. These phenomenon should be considered in design procedures as their effect on structural loading can be significant.

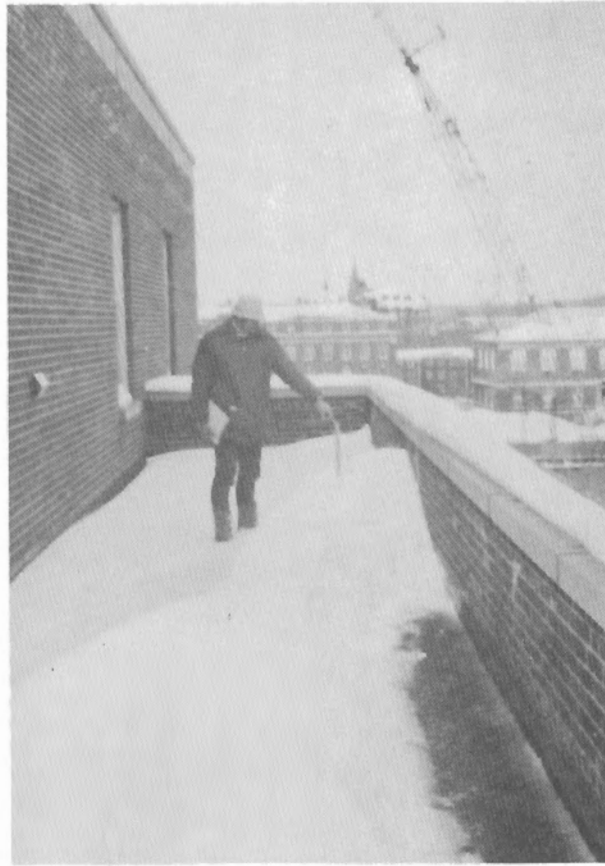
FIGURE 9
Drifting Snow

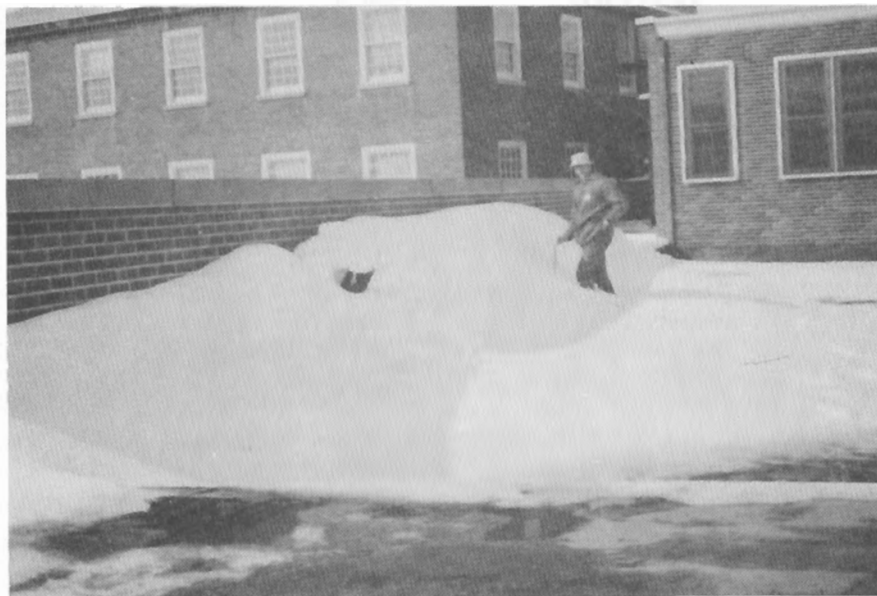
FIGURE 10
Drifting Snow

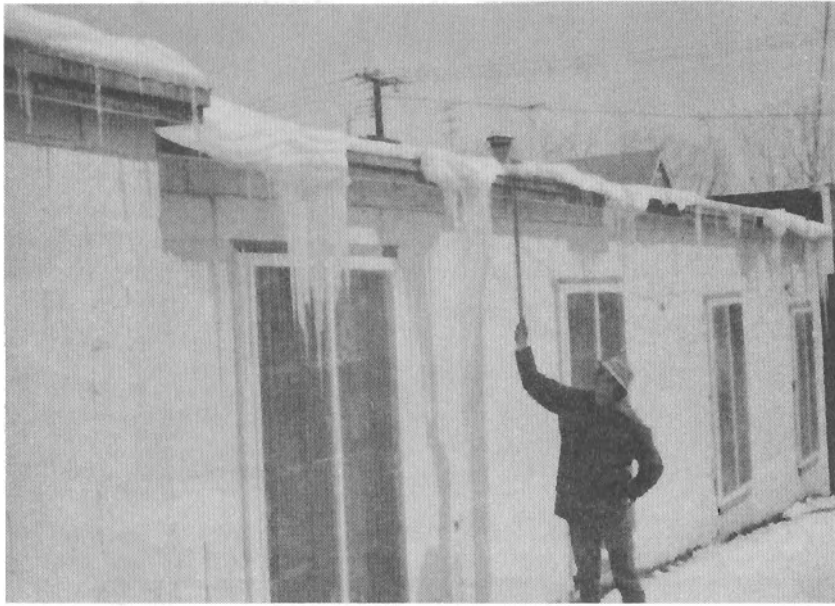
FIGURE 11 Eave Icing
