River Ice Conditions Determined from ERS-1 SAR

L.W. GATTO
Geological Sciences Branch
U.S. Army Cold Regions Research and Engineering Laboratory
72 Lyme Road
Hanover, New Hampshire 03755-1290 U.S.A.

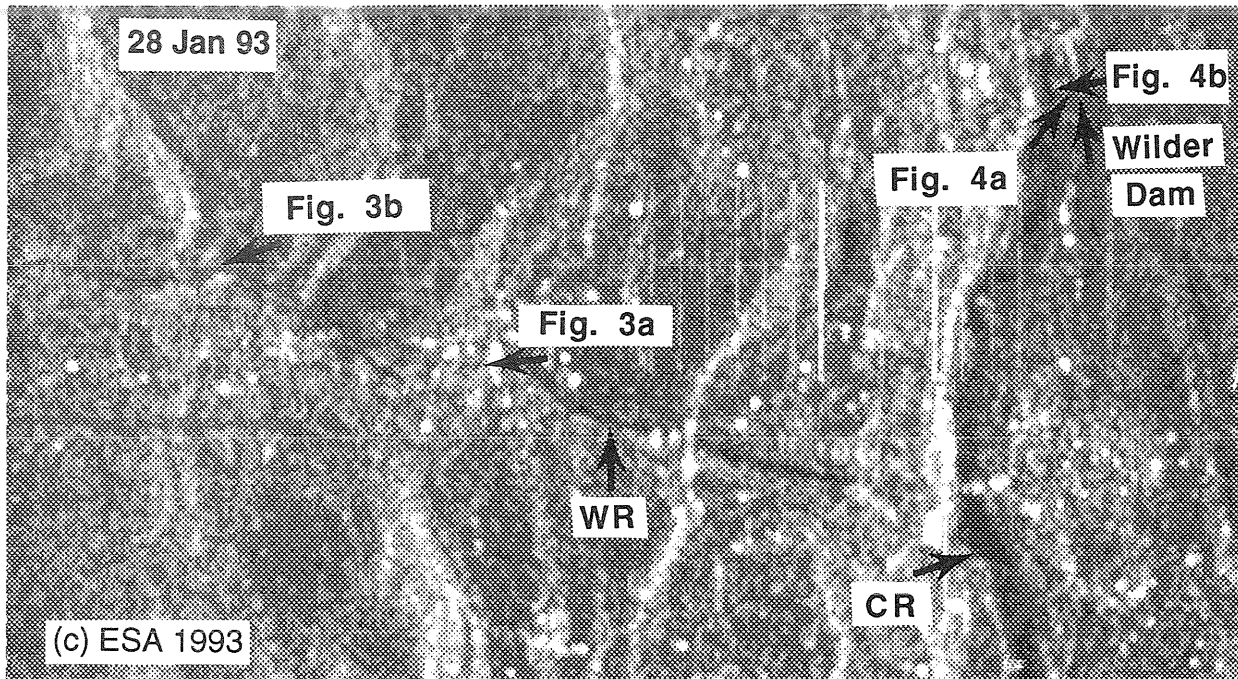
Figure 2. SAR image of the confluence of the Connecticut (CR) and White (WR) Rivers, VT, 28 January 1993.

The White River is the shallowest and narrowest of the three rivers (Table 1) and thus is more difficult to see distinctly on the SAR image (Fig. 2) than the other rivers. I surveyed the White River along the reach included within the area imaged by the SAR (Fig. 1) on 28 January and observed a variety of ice conditions. Near its confluence with the Connecticut River, approximately half the channel was open with frazil pans floating in the open water, but this condition is not apparent on the SAR image. Areas of thin

cover except along the shoreline. Smooth ice produces low backscatter and appears gray on the SAR image. On the upstream side of Wilder Dam (Fig. 2) the ice is smooth in the middle of the river while the nearshore ice is rough and has snow ice at the surface (Fig. 4a). The SAR image shows the gray smooth mid-river zone and a lighter (more backscatter) nearshore zone. The open water downstream of the dam (Fig. 4b) is black due to no radar backscatter (Fig. 2). The ESA SAR image of the river north (Fig. 5a) and west (Fig. 5b) of Hanover shows reaches of smooth ice with low backscatter (gray) in the middle and nearshore areas of the river (Fig. 6). The ice near Ledyard Bridge (Figs. 5b and 6b) is 28 cm thick near shore and 15 cm thick about 30 m offshore.

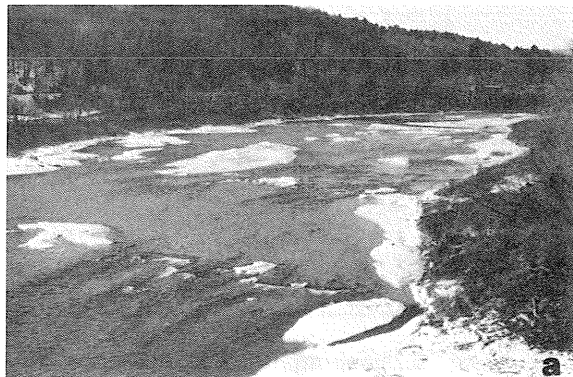
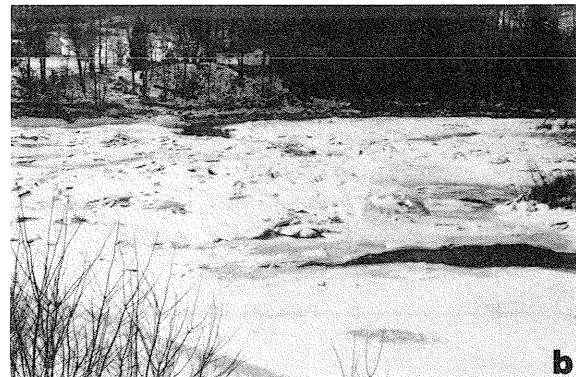
Figure 3. Hand-held photos of the ice conditions on the White River, 28 January 1993.

shore ice and open water (Fig. 3a) appear as dark reaches and it is very difficult to determine if ice is present at all. An ice jam on the river (Fig. 3b) is difficult to distinguish on the SAR image because the river is narrow and there is an island at the jam site. With the spatial resolution of the imagery of about 30 m, the features within narrow reaches of the White River are lost and become indistinct.

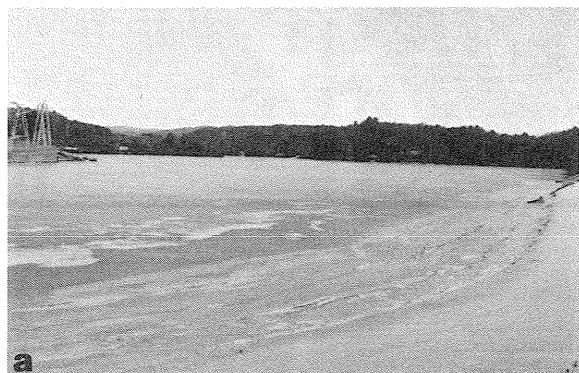
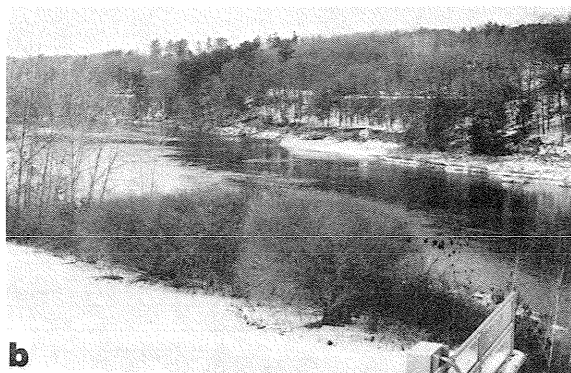
Figure 4. Hand-held photos of the Connecticut River near Wilder Dam, 28 January 1993.

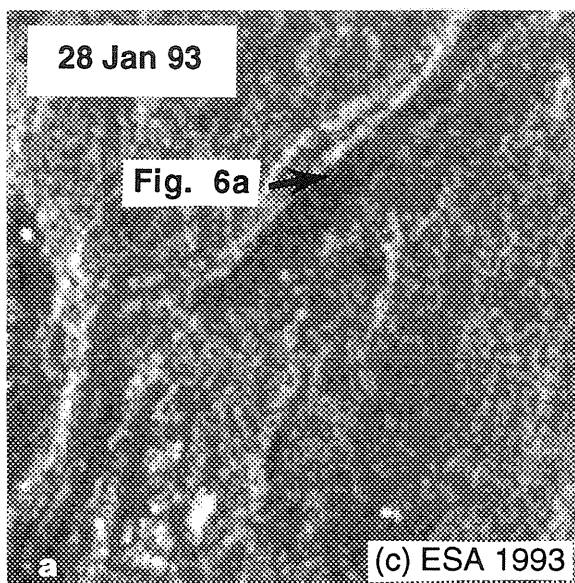
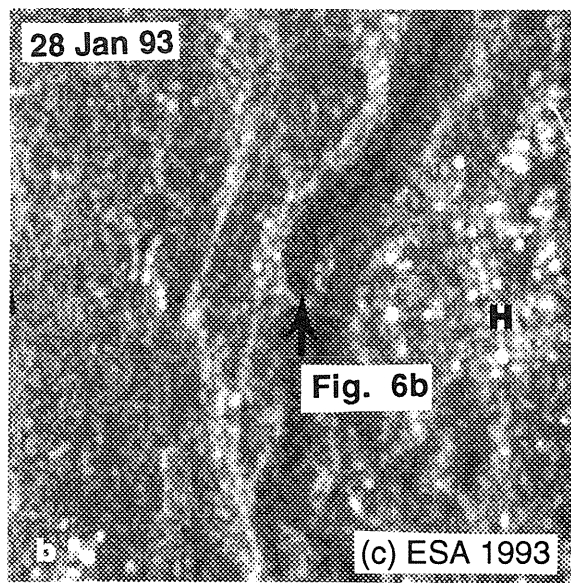
Figure 5. SAR images of the Connecticut River north and west of Hanover (H), NH, 28 January 1993.

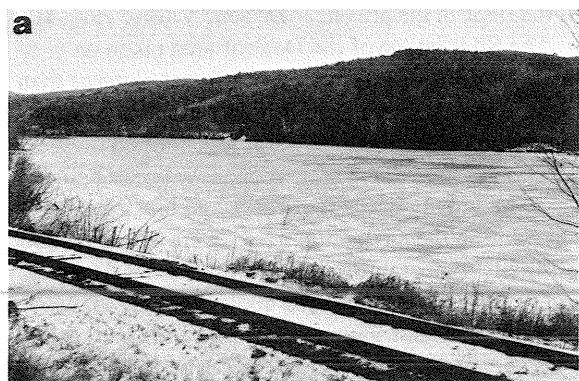
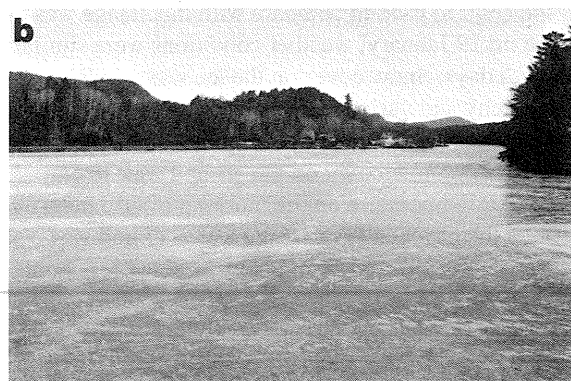
Figure 6. Hand-held photos of the Connecticut River north and west of Hanover, NH, 28 January 1993.

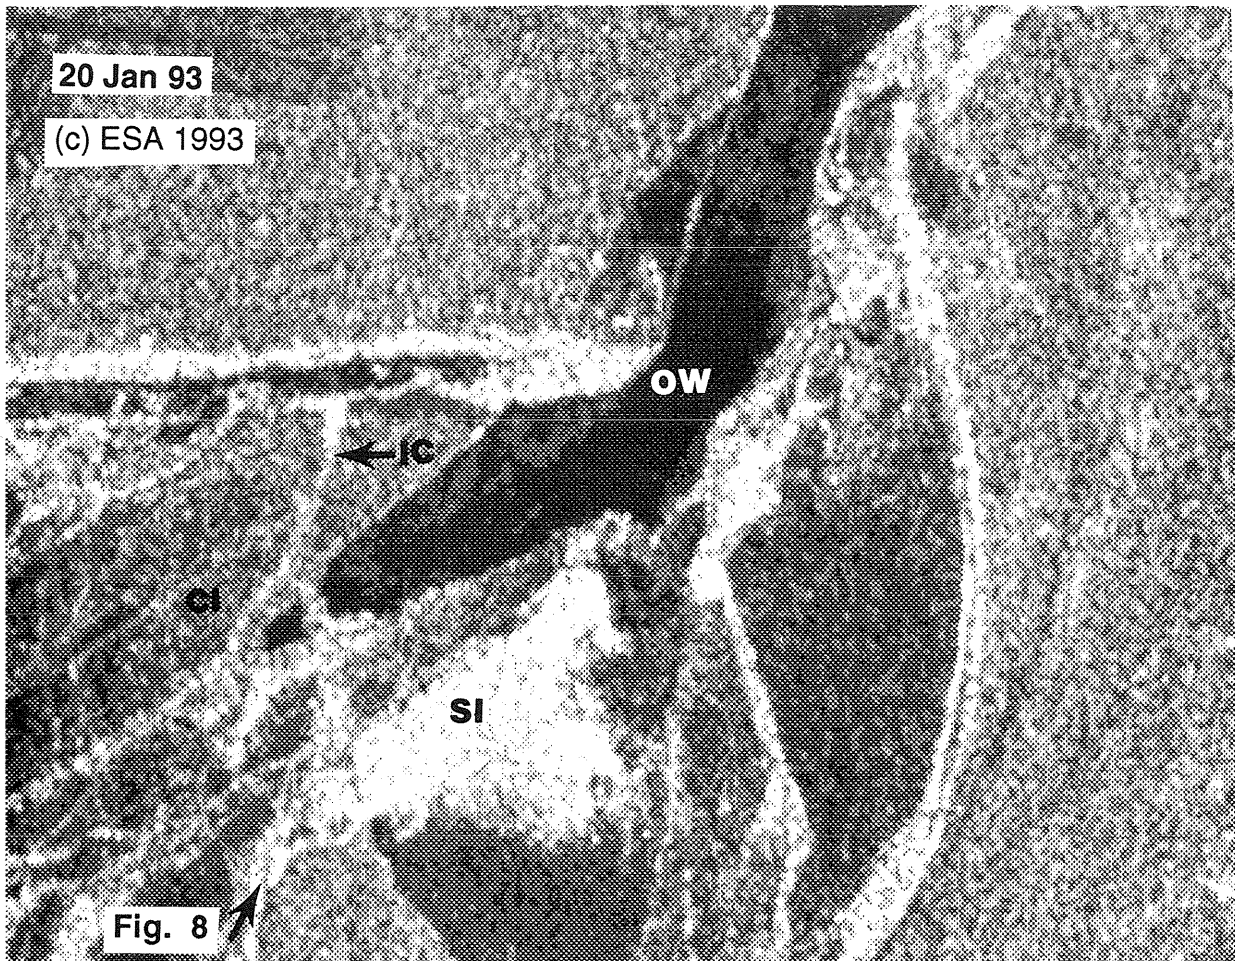
Figure 7. SAR image of the St. Marys River upstream of the Soo Locks, MI, 20 January 1993; OW-open water, SI-snow ice, CI-clear ice, IC-ice cracks.

shows up very distinctly on the SAR. The SAR image taken on 20 January (Fig. 7) clearly shows the open water and snow ice, clear ice, ice cracks and

associated ice ridges through the narrow reach upstream of the Soo Locks. The aerial oblique photograph (Fig. 8) used to compare with this image was taken on 19 January; weather conditions were similar on both days. Snow cover on the ice was windblown and patchy and varied from no snow away from shore to unknown depths near the shoreline where the snow had drifted. Snow cover on the ground was 38 cm deep. Air temperature on the morning of 20 January around the time the SAR image was acquired was about -5.6°C and had been below freezing for about the previous 15 days. The snow was dry and cold and contributed very little to the backscatter reflected from the ice. Thus, the ice signatures made on the image resulted from the backscatter from the ice alone and was not a combination of reflections from the snow and ice.

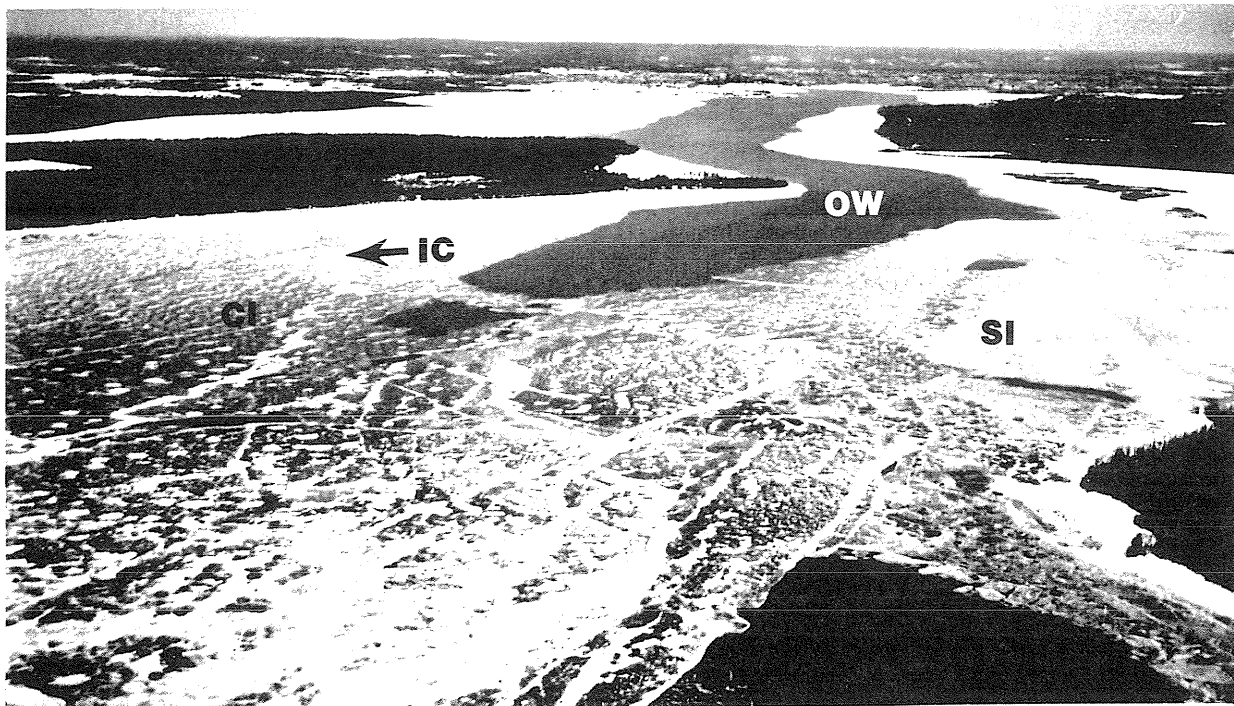
Figure 8. Aerial photo of the area in Figure 7, 19 January 1993.

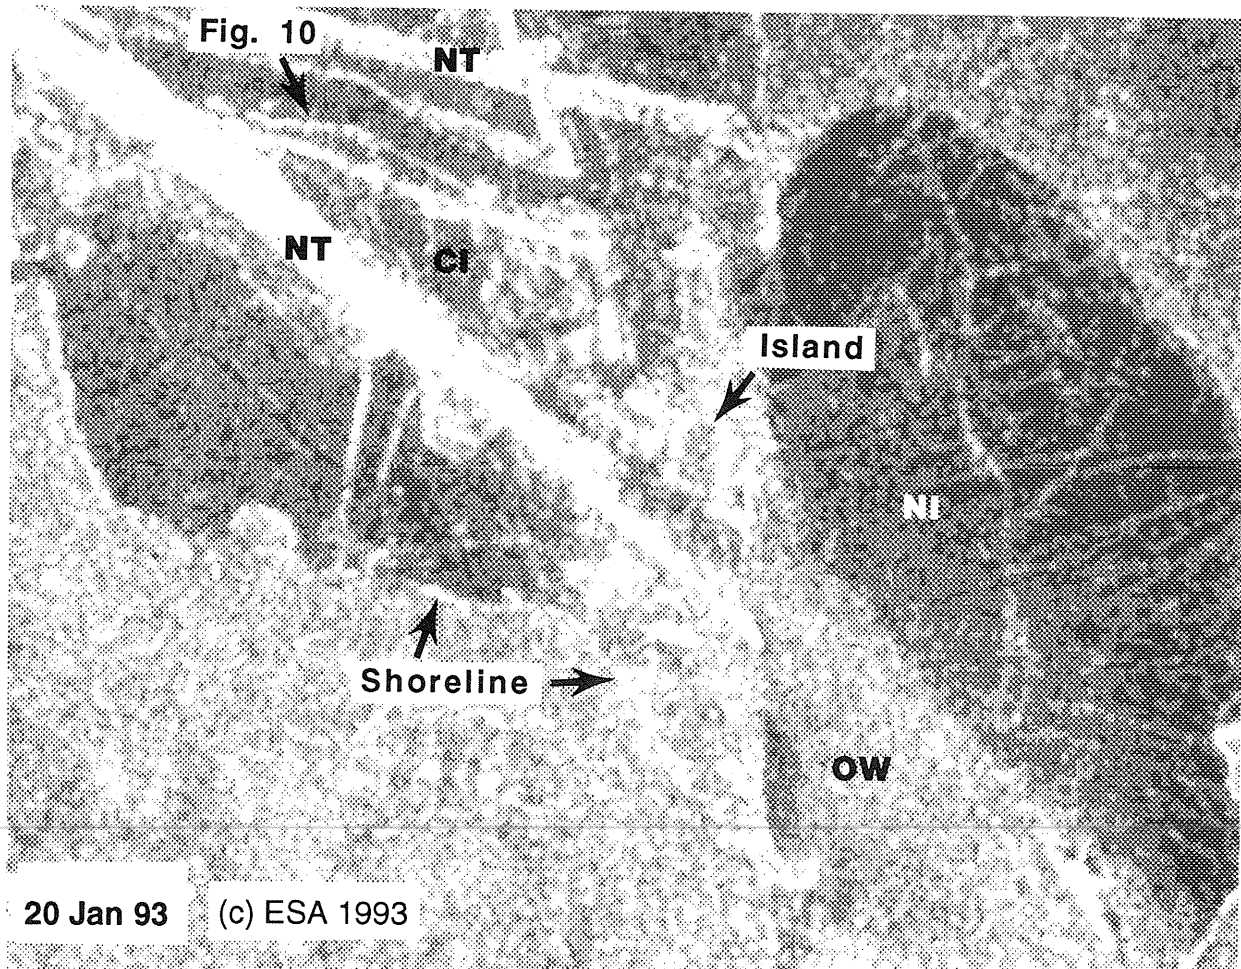
Figure 9. SAR image of the St. Marys River near DeTour Village, 20 January 1993; NI-new ice, NT-navigation track, CI-clear ice, OW-open water.

This 20 January SAR image also distinguishes the open water, the new ice recently formed along the west side of DeTour Passage (Fig. 9), the upbound

and downbound navigation tracks through the ice around the island, and the clear ice that covers most of the river in the area near DeTour Village (Fig. 10).

The SAR image of the DeTour area taken on 6 February (Fig. 11) shows very different patterns than the 20 January image (Fig. 9). The distinction between the land and the ice is far less defined on the 6 February image; the area of open water was much larger and many of the ice cracks and brash ice features within the navigation tracks were not as distinct. The daily temperatures for each of the four days before 6 February had reached above freezing and about 3 cm of snow and some of the surface ice had melted. This changed the surface characteristics of the ice and the snow on the ground enough to alter the backscatter from these areas. Air temperature on the morning of 6 February around the time the image was acquired was about -25°C ; thus, the ice and snow surfaces between 20 January and 6 February had been changed substantially.

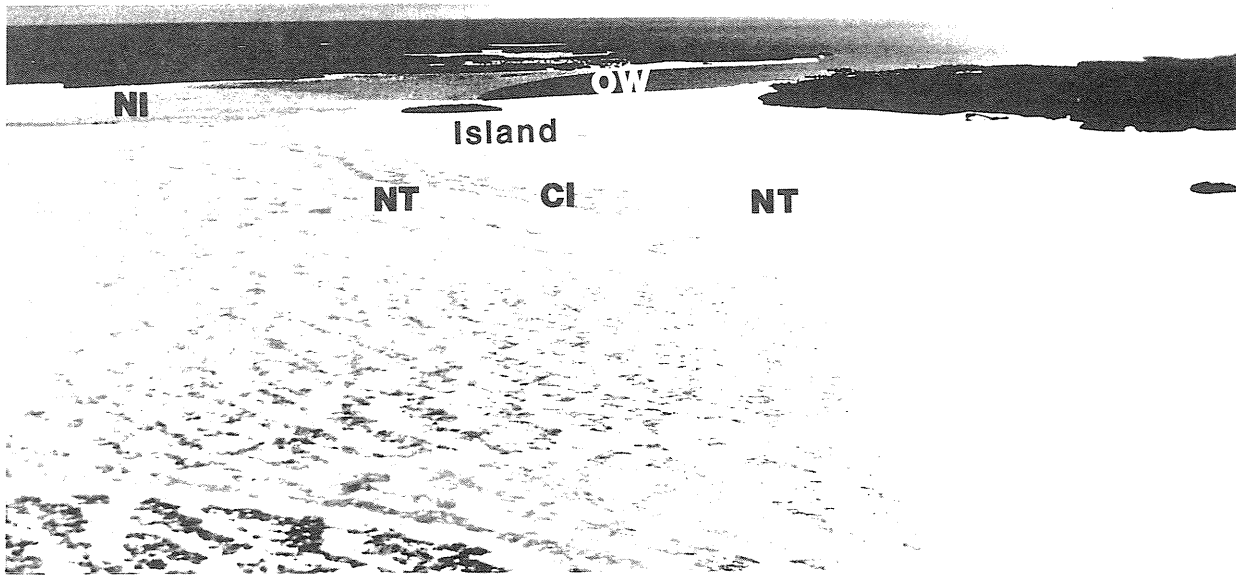
Figure 10. Aerial photo of the area in Figure 9.

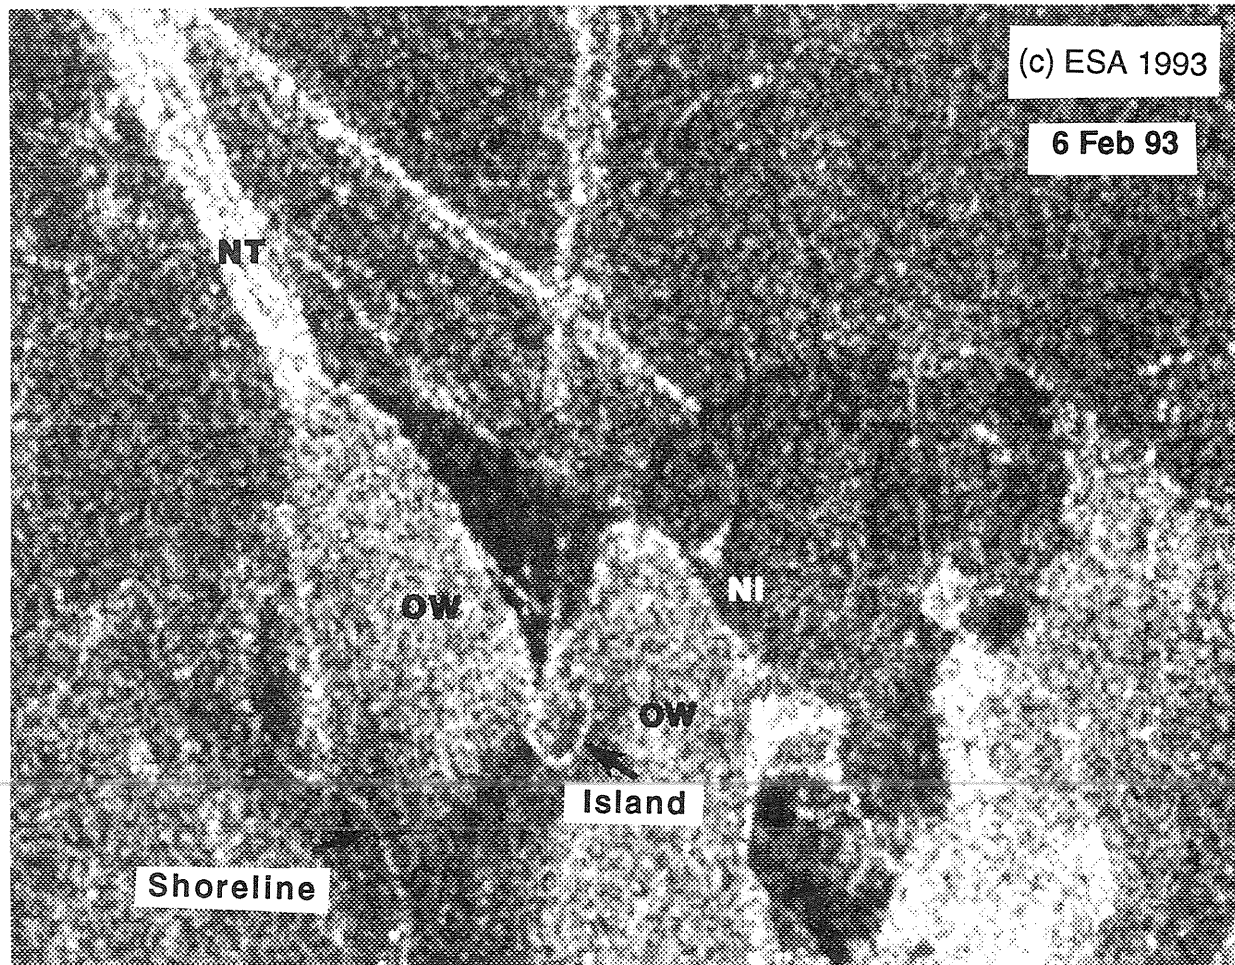
Figure 11. SAR image of the St. Marys River near DeTour Village, 6 February 1993; NI-new ice, OW-open water.

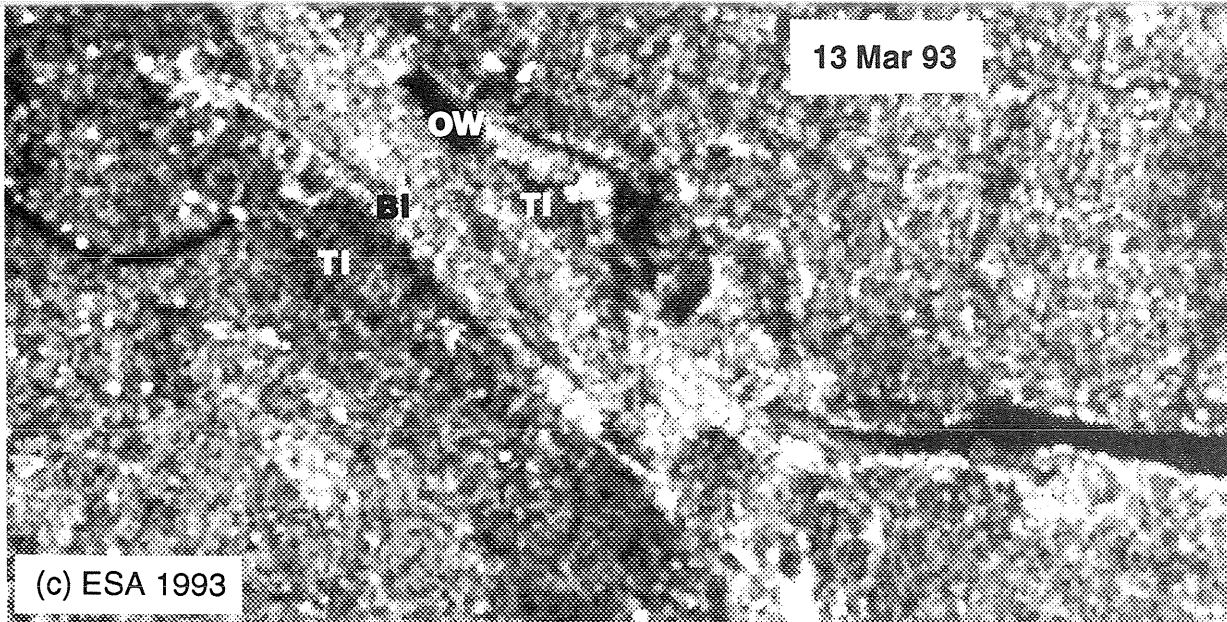
Figure 12. SAR image of the Soo Harbor area, St. Marys River, 13 March 1993; TI-thin ice, BI-broken ice, OW-open water.

The SAR image taken on 13 March (Fig. 12) shows the large area of open water, an area of thin ice along the north shore and a zone of broken ice along the south shore within the Sault Ste. Marie harbor. The ice in this zone has snow ice that is 25 cm thick on 18 to 38 cm of clear ice. The open water through the navigation channel downstream of the harbor is also well defined on this image. The downstream end of the open water is composed of refrozen floes and brash ice and has a ridged and rough surface. The nearshore ice along this open reach is 8 to 13 cm of snow ice on 10 to 28 cm of clear ice.
