SNOW STUDIES ASSOCIATED WITH THE SIDEWAYS MOVE OF DYE-3

Wayne Tobiasson

U.S. Army Cold Regions Research and Engineering Laboratory
Hanover, New Hampshire

Proceedings of the Eastern Snow Conference, 36th Annual Meeting, Alexandria Bay, N.Y., June 7-8, 1979.

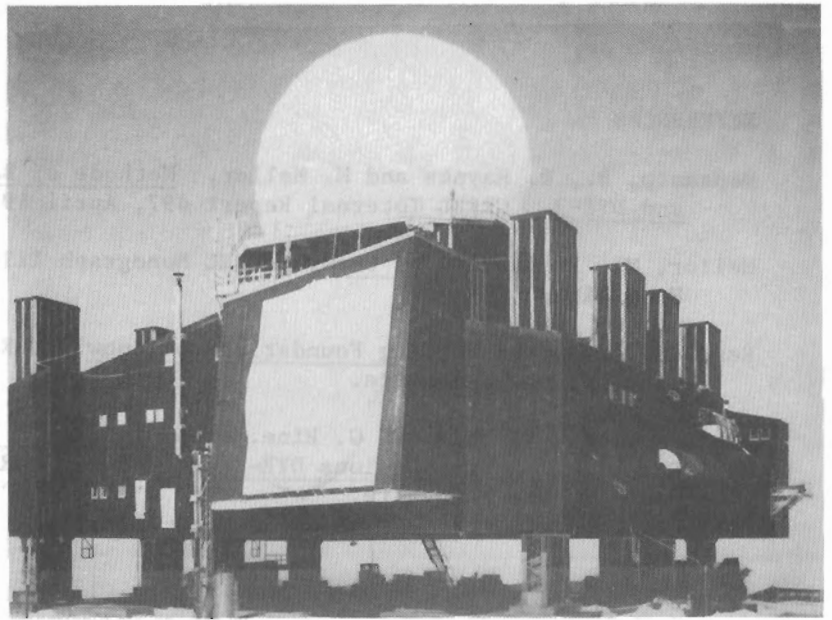
As shown in Figure 2, DYE-3 is elevated on columns. Periodically the columns are extended and the elevated composite building is raised to account for the 4 ft (1.2 m) of snow that accumulates annually at DYE-3. When built in 1959-60, the footings that support the structure were placed 32 ft (10 m) below the surface where snow with an adequate bearing capacity is located. In 1977 those footings were 100 ft (30.5 m) below the current snow surface. The columns which support the building require lateral support which is provided by subsurface trusses isolated from the adjacent snow by a timber and plywood box called the truss enclosure. The configuration of the original trusses is shown in Figure 3a. Truss additions in 1967 and 1972 are shown in Figures 3b and 3c, respectively. The truss enclosure as it looked in 1962 is shown in Figure 4. Its walls are built of studs in much the same way that a conventional framed dwelling is constructed.

Figure 2. DYE-3 from the surface. Note the bulldozers for scale.

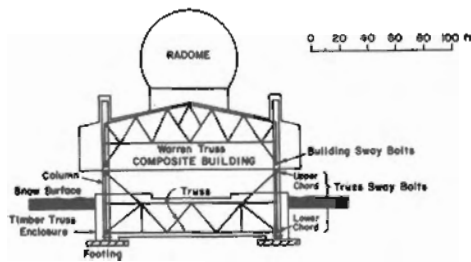
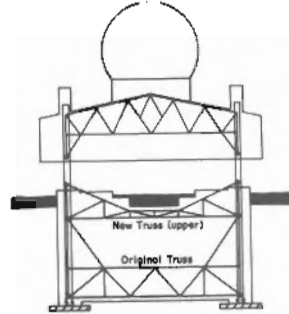
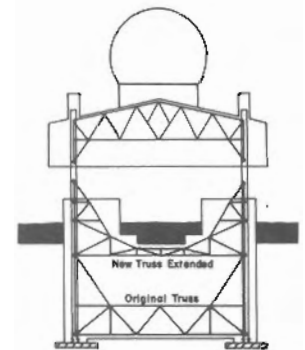
a. As built in 1959-60

b. New truss installed in 1967

c. New truss extended in 1972

Figure 3. Cross-sections of the DYE-3 structural frame.

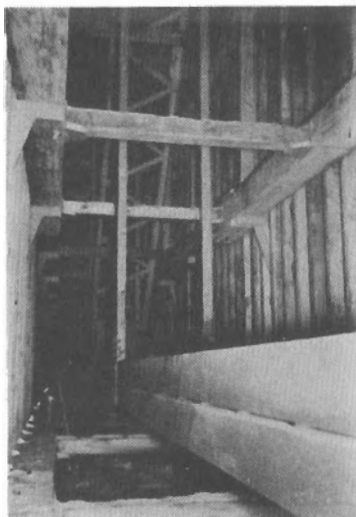
Figure 4. Within the truss enclosure in 1962 (CRREL photo by S. Reed).

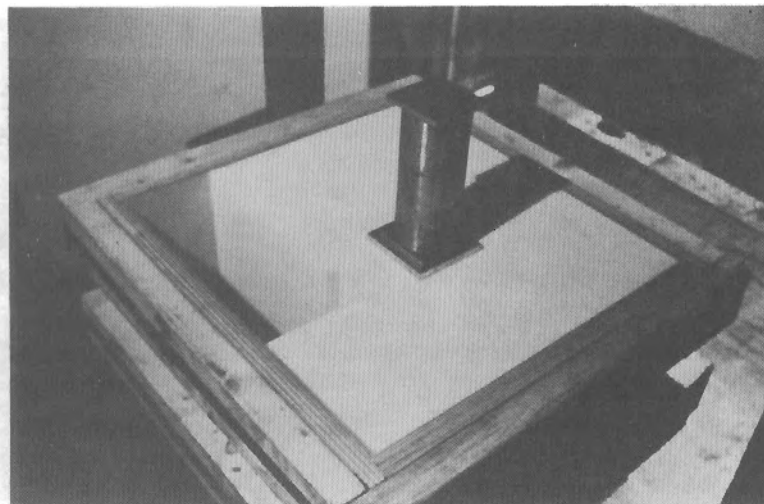
Unconfined compression tests of the same snow indicated that the snow supporting the model failed at a stress 3-1/2 to 7 times the unconfined compressive strength of that snow. These tests were somewhat primitive and the surface snow was not homogeneous. To better define the model/unconfined stress ratio, additional tests were conducted in the cold rooms of CRREL in Hanover, New Hampshire (Fig. 10). The model/unconfined stress ratio for these tests varied from 4.5 to 5.0. With knowledge of the unconfined compressive strength of the snow that would support the actual footings, the load expected to cause failure of those footings could be estimated.

The unconfined stress at failure ranged from 60 to 350 psi (410 to 2400 kPa) except for one sample which failed at 25 psi (170 kPa).

It was obvious that essentially all the snow had an unconfined strength exceeding 25 psi (170 kPa) at 14°F (-10°C) and that the model/unconfined stress ratio certainly exceeded 3. Using these two very conservative values, the foundation failure load would certainly exceed 75 psi (520 kPa) (i.e. 11,000 psf).

Figure 10. Model footing test conducted on a testing machine in a CRREL cold room.

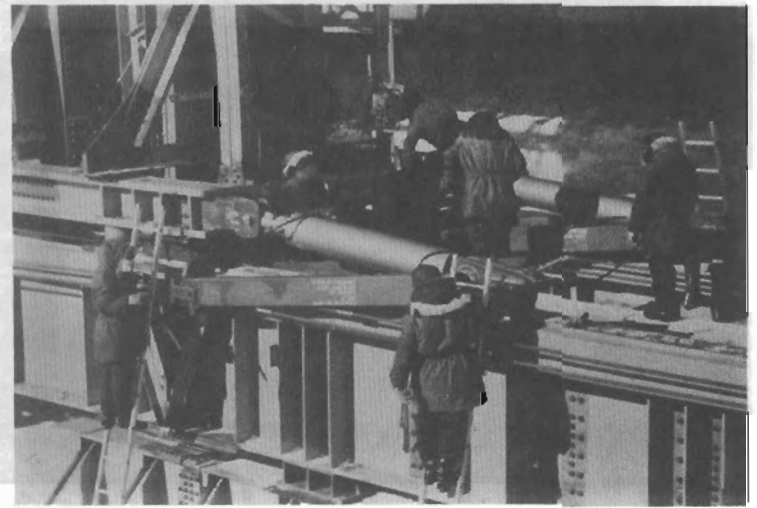
Figure 14. Hydraulic jacks used to pull the building along the girders.

Danish Arctic Contractors (DAC) was awarded the contract to move the building. During the summer of 1977 new footings were built on the snow (Fig. 11), large girders were built on them (Fig. 12) and trusses and girders were installed under the building (Fig. 13). Hydraulic jacks were installed to pull the building along the tracks (Fig. 14). On 2 September 1977 with the columns severed and the weight of the building on rollers, the sideways move began. Four days and 210 ft (64 m) later the building was in its new position (Fig. 15). No particular problems were encountered during the move. The building was occupied and functional the entire time. During the move Bob McLemore of M&E and I measured the settlement of all footings. The total settlement was about 3/8 in. (1 cm) which is in line with the predicted value considering the move took only four days and it was a colder than normal summer.

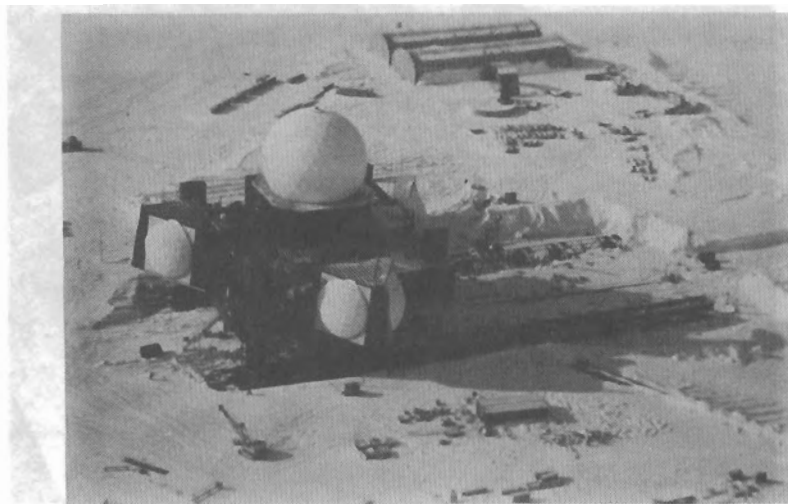
Figure 15. Air photo of DYE-3 shortly after the 210 ft (64 m) sideways move.

In 1977 DYE-3 was moved 210 ft (64 m) sideways onto a new undistorted foundation. The actual move took four days and went smoothly.
